Open Journal of Radiology and Medical Imaging

Review Article

Foreign Bodies in the Female Reproductive Tract

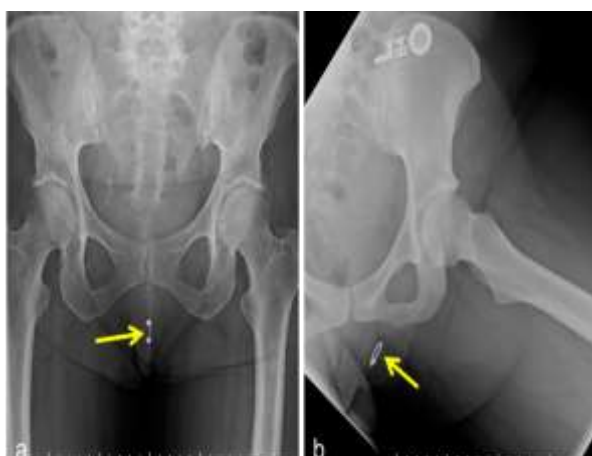
Figure 1: Linear, barbell shaped (a) and ring shaped (b) genital piercings.

Genital piercing is undertaken for a variety of reasons: aesthetic, ethnic expression, and in some cases, as form of self-mutilation or body modification [1]. Genital piercing in women usually occurs in the soft tissues surrounding the vagina such as the clitoral hood, inner labia, and outer labia [2]. Piercings of the clitoris itself or perineal area are less common [1]. The jewelry used in such piercings is usually composed of a radiopaque material such as stainless steel or gold and may appear circular (ring, hoop) or linear (stud, barbell) in shape [2]. Genital piercings can here be seen as incidental findings on hip radiographs (Figure 1a,b). Complications arising from genital piercings include infection, keloid formation, and interference with barrier contraceptive use [1,2].

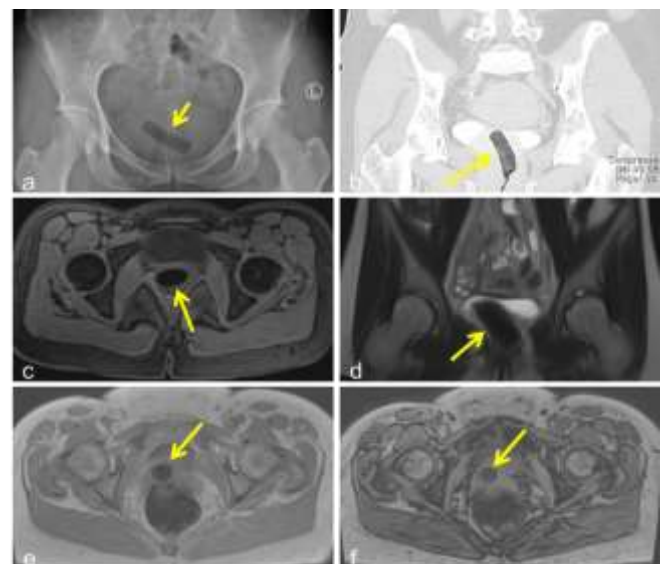
Figure 2: Air trapped within tampon fibers causes a radiolucent appearance on x-ray (a) and CT (b). Tampons appear hypointense on T1 (c) and T2 (d) weighted MRI, again due to trapped air. Blooming (increase in hypointensity) can be seen on the in-phase (e) compared to out-of-phase images (f).

on a Colorado physician's design of surgical cotton with an accompanying cardboard applicator [3]. The purpose of a tampon is to absorb blood during menstruation, and so after placement a tampon will conform to the shape of the vaginal canal. They appear radiolucent on x-ray and CT, due to air trapped within the fibers of the tampon (Figure 2a,b). On MRI, tampons appear hypointense on both T1 and T2 weighted MRI images, again due to trapped air (Figure 2c,d). Blooming artifact (increase in hypointensity) can be seen on in-phase compared to out-of-phase images (when in-phase images are acquired with a longer echo time), as susceptibility artifact from the trapped air is more apparent with the longer echo times (Figure 2e,f). The most feared complication of tampon use is toxic shock syndrome [4].

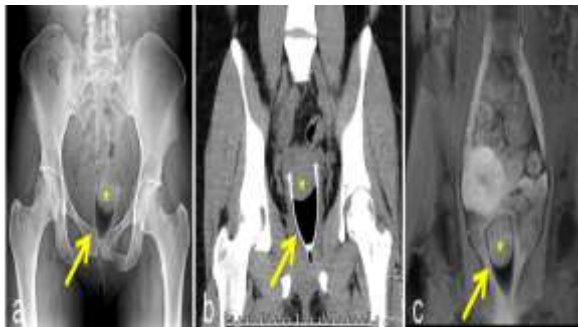
Figure 3: A menstrual cup appears as a high-attenuation, cup-shaped structure (arrow) with gas between the cup and the cervix (asterisk) on x-ray (a) and CT (b). It appears hypointense on T1-weighted MRI (c).

similar fashion to tampons. They function by catching menses in a small reservoir. The cup can then be removed, emptied, cleaned, and replaced. The expected location of a menstrual cup is within the vagina, with the wide end surrounding the cervix and the handle near the introitus. On x-ray and CT, it appears as a high-attenuation, cup-shaped structure (Figure 3a,b). The area between the cup and the cervix may appear lucent due to trapped air, or may contain an air-fluid level if menses are present. On T1-weighted MRI sequences, it appears as a hypointense, cup-shaped structure (Figure 3c). Complications of menstrual cup placement are radiographically occult, and include cramping and leakage [5].

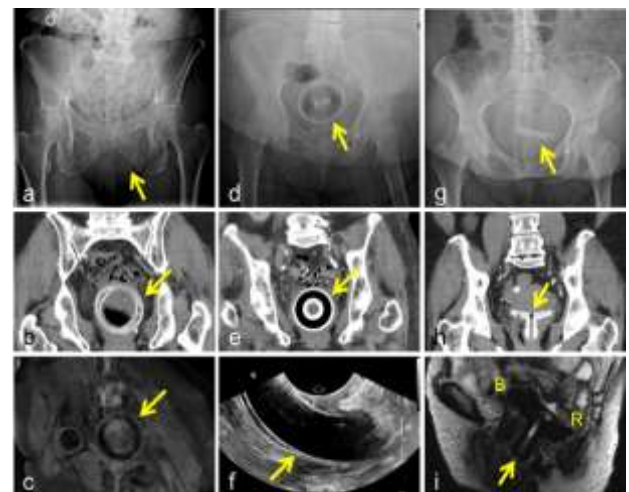
Figure 4: Ring pessary on x-ray (a), CT (b), and T1-weighted MRI (c); Donut pessary on x-ray (d), CT (e), and transvaginal ultrasound (f); Gelhorn pessary on x-ray (g) and CT (h); Sagittal T2-weighted MR image of Gelhorn pessary (arrow) eroding into bladder (B) and rectum (R) (i).

attenuation structures on x-ray and CT (Figure 4a,b,d,e,g,h). In the case of ring- and Gelhorn-type pessaries, perforations in the body of the pessary may contain air and appear lucent. In the case of the donut-type pessary, the core may appear lucent. On ultrasound, ring- and donut-type pessaries appear as anechoic structures surrounded by an echogenic rim directly underneath a transvaginal probe (Figure 4f). Pessaries appear hypointense on both T1 and T2 weighted images (Figure 4c). Common complications of pessary use include discomfort, vaginal discharge, bleeding, and constipation [9]. Rarely, more severe complications can arise. There have been multiple case reports of neglected pessaries eroding through the vaginal wall and causing vesicovaginal or rectovaginal fistulas, requiring surgical removal (Figure 4i) [10,11].

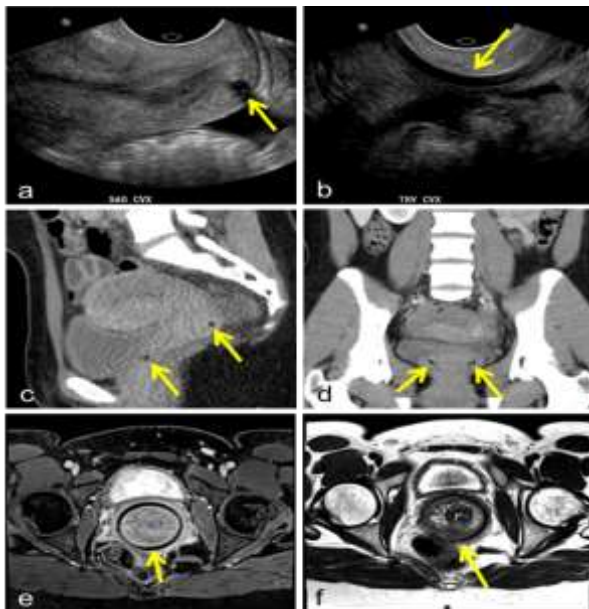
Figure 5: Contraceptive ring on ultrasound (a, b), CT (c, d) and T1- (e) and T2- (f) weighted images.

therefore anywhere within the vagina, depending on user placement. On ultrasound and CT, contraceptive rings appear as thin, anechoic or hypodense structures, respectively (Figure 5a-d). Contraceptive rings also appear hypointense on both T1- and T2- weighted MRI (Figure 5e,f). The major complication of contraceptive ring placement is expulsion; however, there have been several case reports of inadvertent placement into the bladder [13-14].

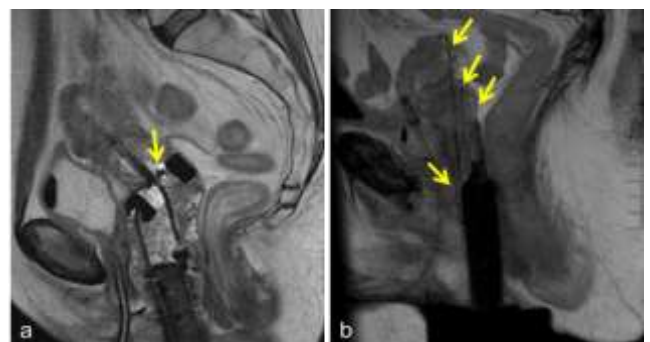
Figure 6: T1 weighted MR images of intracavitary (a) and interstitial (b) approach brachytherapy applicators.

a ring may be used to encircle the cervix; in this case the configuration is called tandem and ring (T & R) (Figure 6a). Intracavitary brachytherapy is usually employed when tumor location and size permits the appropriate placement of a T & O or T & R configuration, such that the area reached by radiation will entirely encompass the tumor [15]. If the tumor is large or intracavitary applicators cannot be appropriately positioned, interstitial brachytherapy may be considered [15]. In interstitial brachytherapy, multiple applicators are passed directly into affected tissues using a transperineal template. This allows for more flexible delivery of radiation to encompass a larger area of disease (Figure 6b). The most severe complication of a misplaced brachytherapy applicator is unintentional radiation delivery to surrounding tissues, including the rectum and bladder. Improper positioning may also result in an insufficient radiation dose to targeted tissues [15]. To this end, an MRI or CT scan is usually performed after applicator insertion for treatment planning [16].

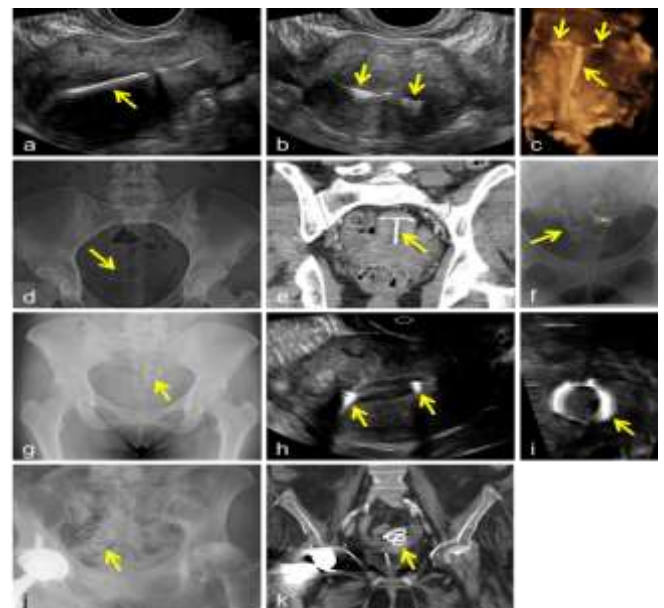
Figure 7: Appropriately positioned T-framed IUD with stem seen completely within the endometrial cavity on sagittal ultrasound (a) and with arms at the fundus on transverse ultrasound (b); position is confirmed with 3D rendering (c). T-framed IUD within the pelvis on x-ray (d) and within the uterus on CT (e). Complete perforation with intraperitoneal T-framed IUD adjacent to the right side of the uterus (asterisk) on hysterosalpingogram (f). Ring-shaped IUD within the pelvis on x-ray (g) and appropriately positioned completely within the endometrial cavity on transverse ultrasound (h) and 3D rendering (i). Lippe's Loop IUD within the pelvis on x-ray (j) and within the uterus on CT (k).

frameless, and ring-shaped. The most frequently used type of IUD varies from country to country: in the US, T-framed devices are most common (Figure 7a-f), while in China, stainless steel rings are most common (Figure 7g-i) [17]. Devices such as the Dalkon Shield and Lippe's Loop are no longer actively in use, but may still occasionally be seen in an older patient (Figure 7j,k) [19]. IUDs generally appear as high-attenuation structures on x-ray and CT, hyperechoic on ultrasound imaging, and hypointense on T1- and T2-weighted MRI.

The correct location for an IUD is entirely within the endometrial cavity [18]. In the case of T-framed IUDs, the arms of the "T" should be at the fundus, with the stem ending above the internal cervical os [18]. Strings, used for IUD retrieval, exit the external cervical os and terminate in the vagina [18]. The most common complication of IUDs is displacement, where the position of the IUD shifts within the endometrial cavity [20]. This affects up to 25% of women using IUDs, and is associated with decreased contraceptive efficacy and an increased likelihood of expulsion. Uterine expulsion, where the IUD moves through the cervix into the vagina, occurs in approximately 3-10% of IUD users [20,21]. Partial expulsion may also occur, and is more common younger women (ages 13-19) [22]. As contraceptive efficacy of the IUD depends on correct placement within the endometrial cavity, users with an expelled or partially expelled IUD are at risk of pregnancy. However, even with a correctly-positioned IUD in place, pregnancy can occur in up to 1% of users [22]. Another complication of IUD use is embedment, where the device erodes into the uterine endometrium and myometrium, but does not perforate the serosa [20]. This occurs in up to 18% of users [20,23]. Treatment includes antibiotics and removal of the device, by surgical hysteroscopy if necessary [24]. The most severe complication of IUD use, complete perforation, is also the rarest, occurring in approximately 0.1% of users [20,25]. In this case, the device penetrates the endometrium, myometrium, and serosa, and may escape the uterus to float freely within the peritoneal cavity (Figure 7f). Management

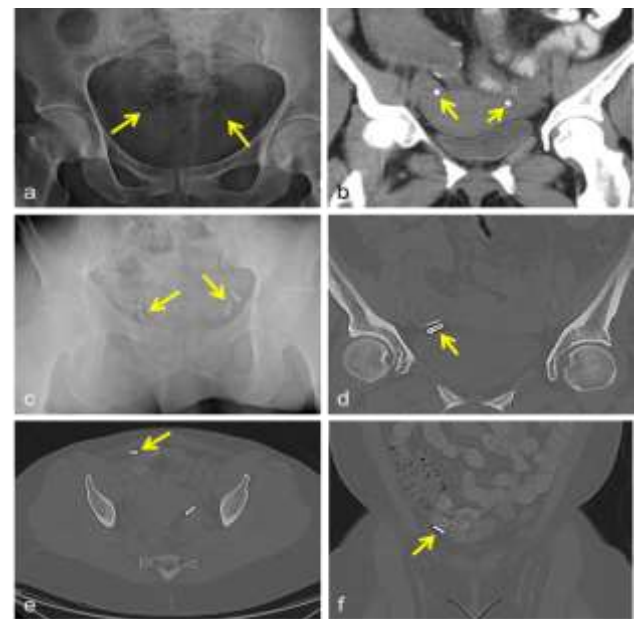
Figure 8: Tubal rings in expected location within the pelvis on x-ray (a) and CT (b). Appropriately positioned toothed clips locked with a stainless steel spring, variously referred to as spring, Hulka, or Wolf clips, on x-ray (c) and CT (d). Filshie clip migration into the peritoneal cavity on axial (e) and coronal (f) CT images.

The most severe complications of laparoscopic tubal ligation tend to occur during or immediately after the procedure, and are related to general anesthesia or the laparoscopic approach [29]. Post-procedurally, infections of the pelvic organs or the wound itself have been reported but appear to be uncommon, occurring in less than 1% of women [29-30]. Complications occurring more frequently after Filshie clip or tubal ring placement include migration and mesosalpingeal injuries, respectively, and are also rare [27,31]. Filshie clip migration (Figure 8e,f) has an incidence of 0.1-0.6% [27,31], and in several cases expulsion through the rectum, urethra, or vagina has been reported [27]. Mesosalpingeal and tubal injuries more commonly occur with tubal ring placement, a finding that has been attributed to the method of ring placement: a loop approximately 2 cm of fallopian tube is

drawn through the ring, which can result in tubal transection or mesosalpingeal hematoma [27]. Unplanned pregnancy occurs equally, albeit rarely, after tubal ring or clip placement (1.7 per 1000 women) [27]. Ectopic pregnancy can also occur after all methods of tubal sterilization, at a rate of 2.4-2.9/1000 procedures [32].

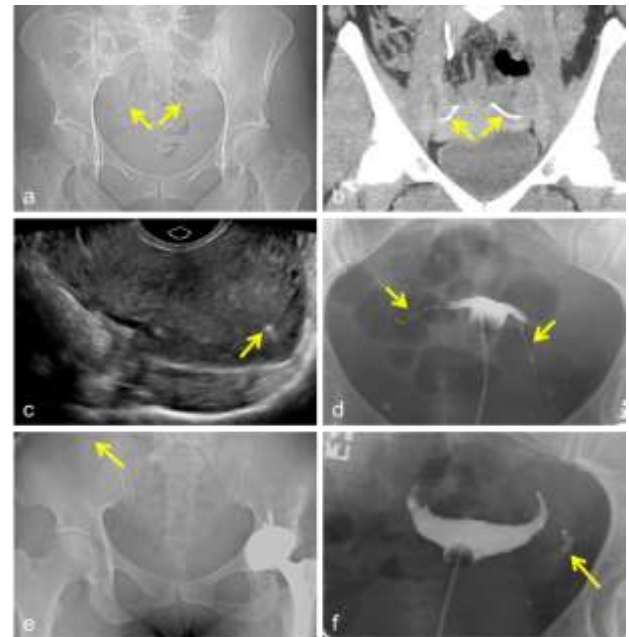
Figure 9: Micro-inserts in expected location within the pelvis on x-ray (a) and CT (b). Sagittal ultrasound image shows a small portion of the micro-insert visible within the uterus (c). Hysterosalpingogram demonstrating complete occlusion of the Fallopian tubes, with no spillage of intra-uterine contrast into the peritoneal cavity (d). Micro-insert migration on x-ray (e). Failed occlusion of the left Fallopian tube with free spillage of contrast into the peritoneal cavity (f).

protruding from the tubal ostium into the uterus (Figure 9a-c) [33,35,36]. After micro-insert placement, a follow up hysterosalpingogram (HSG) should be obtained 90 days later to ensure complete tubal occlusion by fibrosis [37,38]. During the intervening time, women using the device are counseled to continue an alternate form of contraception [33]. If the 90 day HSG shows total occlusion, backup contraception can be stopped; if tubal patency is maintained, then the alternate form of contraception should be continued and the patient should return for another HSG in 6 months (Figure 9d,f) [33,37].

The complications following micro-insert placement are rare, but include chronic pain, infection, nickel allergy, malpositioning (including device migration and expulsion), and unintended pregnancy [39,41]. Device migration into the abdomen is particularly rare, occurring in only 0.04-0.1% of users (Figure 9e) [39,41,42]. In most cases, intra-abdominal migration is asymptomatic. Laparoscopic removal of the device(s) may be considered, however, as there have been several reports of serious complications, including bowel obstruction or perforation [33,39,42]. Unintended pregnancy after micro-insert placement is also uncommon, affecting approximately 0.25% of users after 5 years of follow up [43]. Findings from multiple studies suggest that most of these pregnancies are either already present at the time of device placement, due to lack of backup contraception during the 90 days following placement, or the result of missed or inaccurate follow up imaging [39,44].

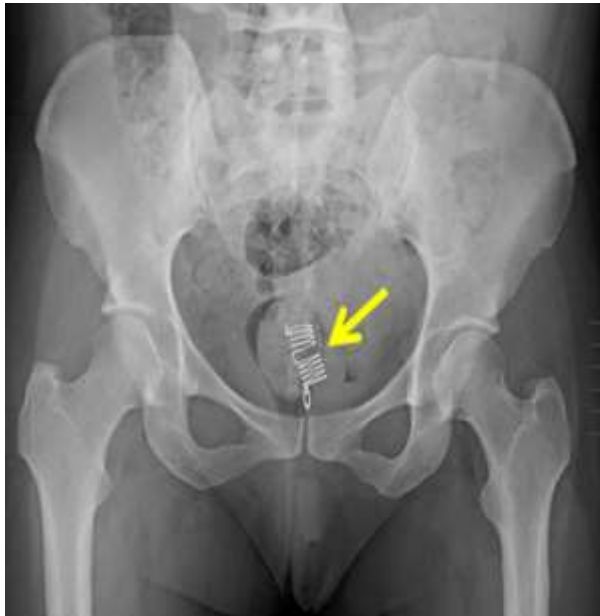
Figure 10: Spring that was self-inserted into the vagina.

Occasionally, foreign bodies are found in the female reproductive tract (usually the vagina) that do not serve a medical or personal care purpose (Figure 10). These objects vary widely, ranging from bottle caps to illicit drugs [45]. They are most frequently seen in children, but may also be present in adults who are mentally incompetent, seeking sexual pleasure, or who are simply curious [46]. The most common complication of a long-retained vaginal foreign body is excessive vaginal discharge, which may be foul-smelling or blood-tinged [45,47]. In a young girl who has not inserted the object herself, sexual abuse must be considered [47].
