## Open Journal of Architectural Engineering

Case Blog

### Typological analysis for knowledge and Conservation of Spread Built Heritage: A case study

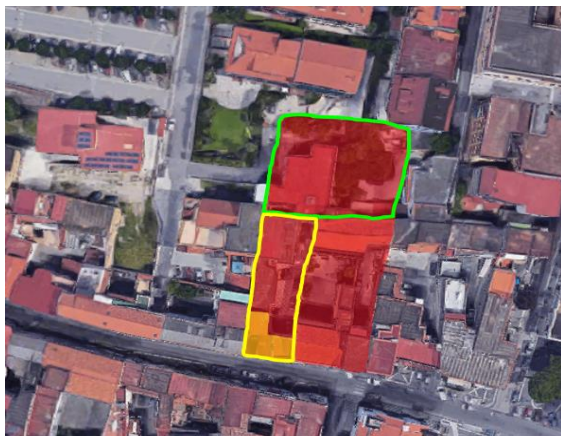
**Figure 3:** Case study (yellow L-shaped shading).

The boundaries of the current court to which the building belongs are also reported (solid yellow line) together with the size of the original court (red shading). Green solid line indicates the old garden size, now partially built. Although all the original courts, including the case study, are now subdivided into several housing units (Figure 3), the typological study at urban scale highlights the need that all renovation projects

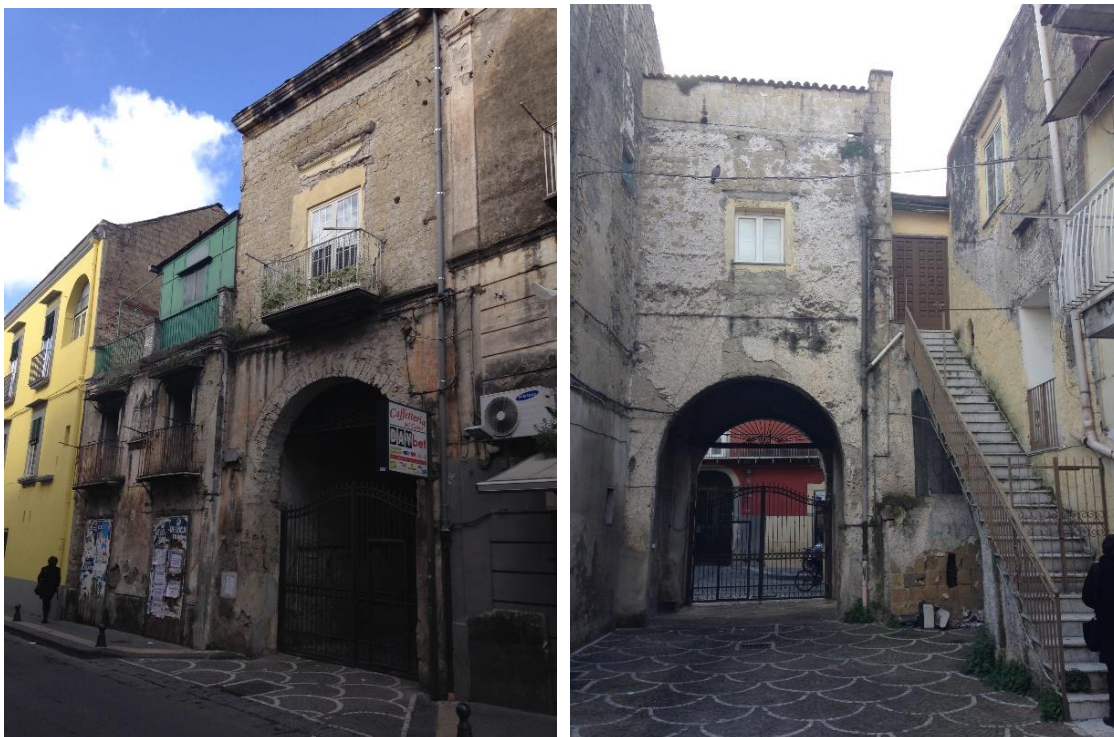
**Figure 4:** South view (left) and north view (right) of the case study.

Over time, probably around the end of the 19th century, the suppenno was replaced by a new floor and then it was rebuilt above the latter. The memory of this second suppenno, demolished for safety reasons in the 90s, when it had lost its original storage function, remains in two masonry tympana (Figure 6) and in a row of tiles, belonging to the removed pitched roof (Figure 4, right panel).

The access to the second floor is possible directly from the courtyard via a steep external staircase: rise and tread are 21 and 26 cm respectively (Figure 4, right panel). Also, second floor has 2 rooms with a

Even the façade shows evidences of the modifications that took place over the years, like the cornices of the nineteenth-century façade, also bearing witness the original size of the French window (Figure 4). The presence of different but well-integrated materials and technologies suggests to respect this overlap in a possible rehabilitation operation by keeping the masonry load-bearing walls and using reinforced concrete or mixed wood-concrete floor slabs.

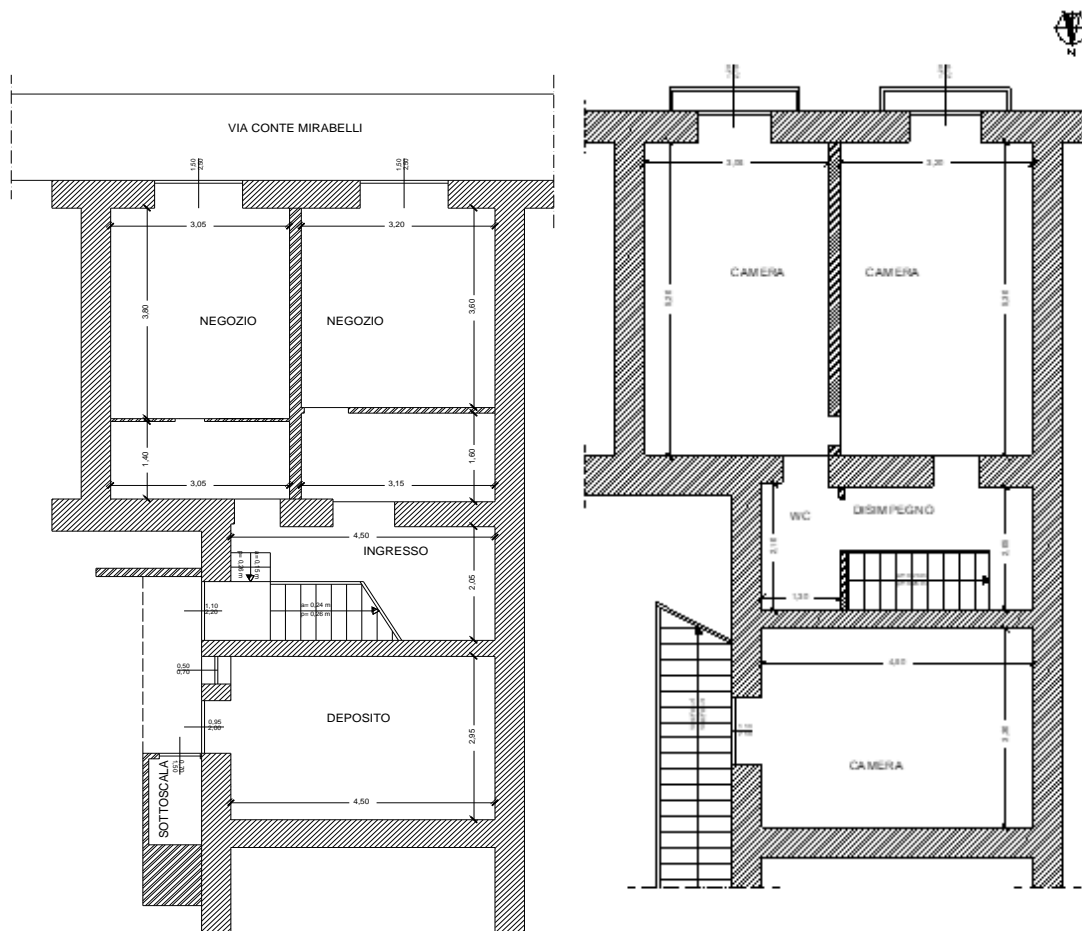
**Figure 5:** Ground floor plan (left) and first floor plan (right).

first floor was generally used as a residence, while the ground floor had a productive or trade end use. The suppenno was intended for storage of agricultural commodities and most of the time had typical arched windows [16]. The ground floor of the studied building, following this outline, consists of two rooms (called tabernae), once used for craft and commercial activities, with access from the street [17]. On

the back of the two rooms there is a staircase leading to the upper floor, with a double entrance from the courtyard. Also, the first floor is constituted by two rooms, as big as the ones below, each with a balcony overlooking the street. On this floor, there is also a small bathroom of about 3 m<sup>2</sup>, with access directly from the stairwell (Figure 5, right panel).

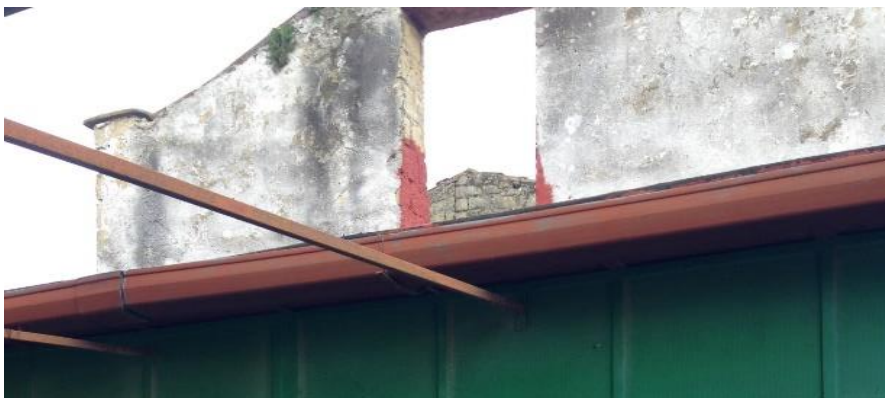
**Figure 6:** Tympanum above the veranda.

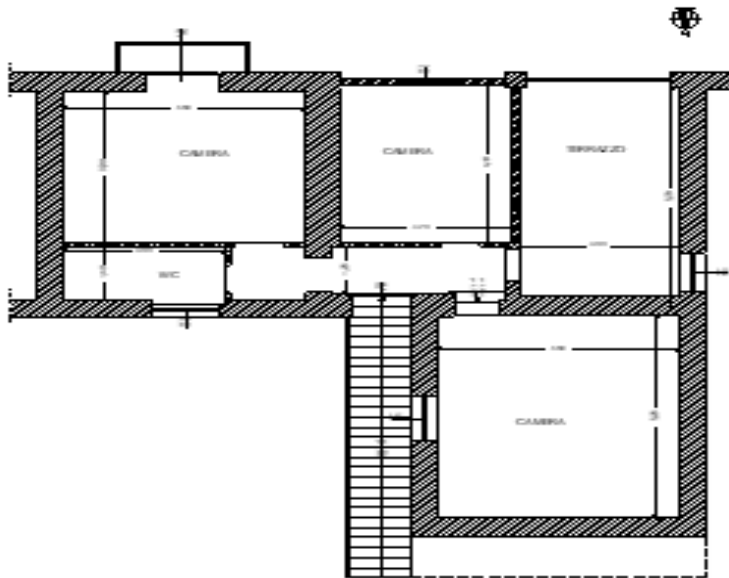
**Figure 7:** Second floor plan.

small bathroom of about 4 m<sup>2</sup>. Initially, these two rooms were separated by an open terrace, through which it was possible to enter both of them. In the '70s, the terrace was partially closed by an unauthorized veranda (later condoned) that allowed, at the same time, a more comfortable entrance to the rooms through an indoor hallway and the creation of an additional room, used as a kitchenette (Figure 7).

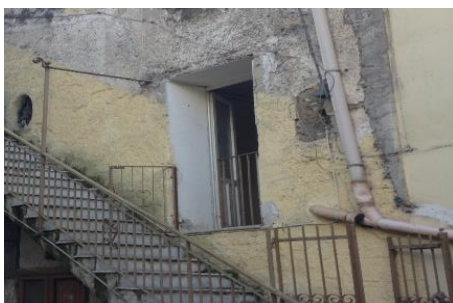
**Figure 8:** Entrance to the external room.

It is interesting to note that along the external staircase a further small mezzanine room has been built up, which can only be accessed by the staircase itself. The lack of a landing and the narrow stairway tread make the accessibility to the room quite poor (Figure 8). The typological invariants at building scale to be preserved are the independence of the floors, together with the commercial vocation of the rooms at the ground floor. Furthermore, the attic with pitched roof should be rebuilt, to restore the pre-existing suppenno.

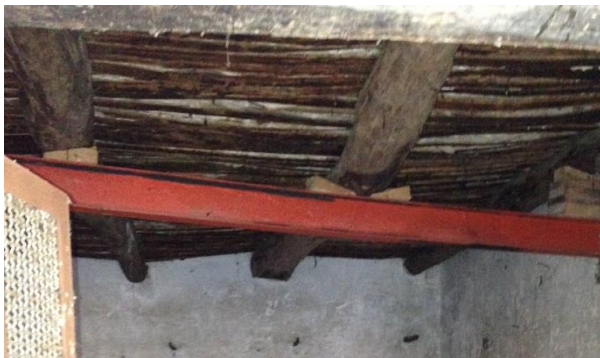
**Figure 9:** Ground floor slab with wooden trunks.

mortar was a hydraulic pozzolana mortar, made with two parts (by volume) of pozzolana and one (or a little more) of grassello, until obtaining a light lead-colored mixture [19]. The roof slabs are made with wooden beams obtained from simple chestnut trunks, rough-hewn and arranged end-to-end (Figure 9), meaning alternating one end with the other so as to ensure, on each side, the same resistance [20]. A rough plank made of halved poles and covered by a 20/40 cm layer of mortar, on which the flooring was then laid, completed the floor [21]. The balconies on the first floor are made with marble slabs on iron supports called gattoni (Figure 4, left panel). The external staircase to access the second floor was built in the '60s in reinforced concrete following the rampant slab scheme. It replaces a pre-existing staircase (a collo d'oca), where a rampant barrel vault, leaning against the opposite wall, supported basalt steps.
